Road and Railroad Crossing Inventory

Starkweather Coulee

U.S. Department of the Interior
Bureau of Reclamation
Great Plains Region
Dakotas Area Office

October 2004

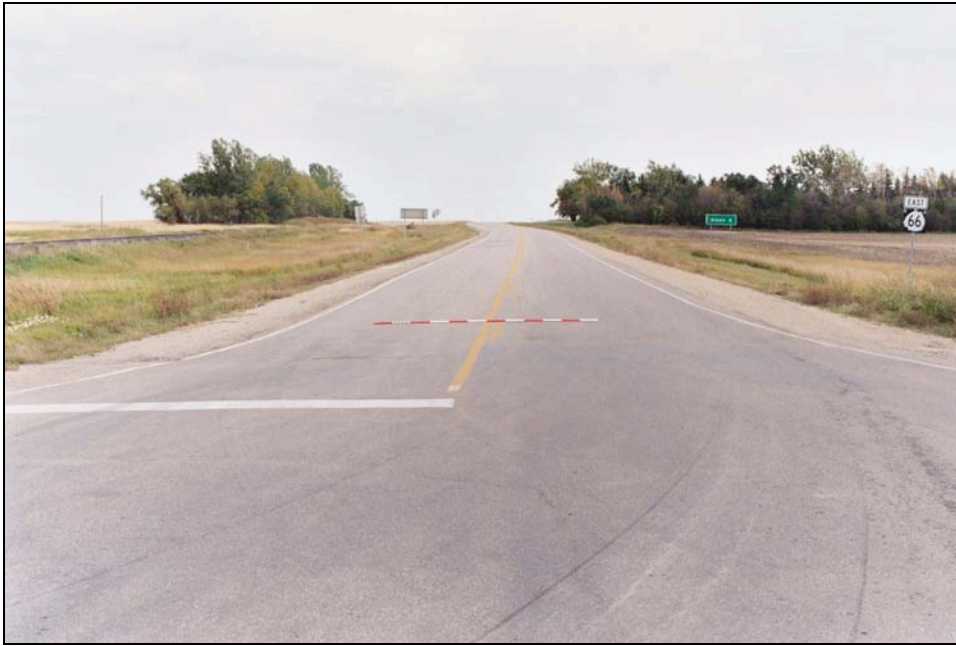
S35 Center of road crossing across one 60" CMP, looking east (09-29-04), Section 31 & 6, T159 & 160N, R63W, N 599147.63, E 2401506.26, elevation 1582.7 @ center of Hwy 66, top of asphalt.

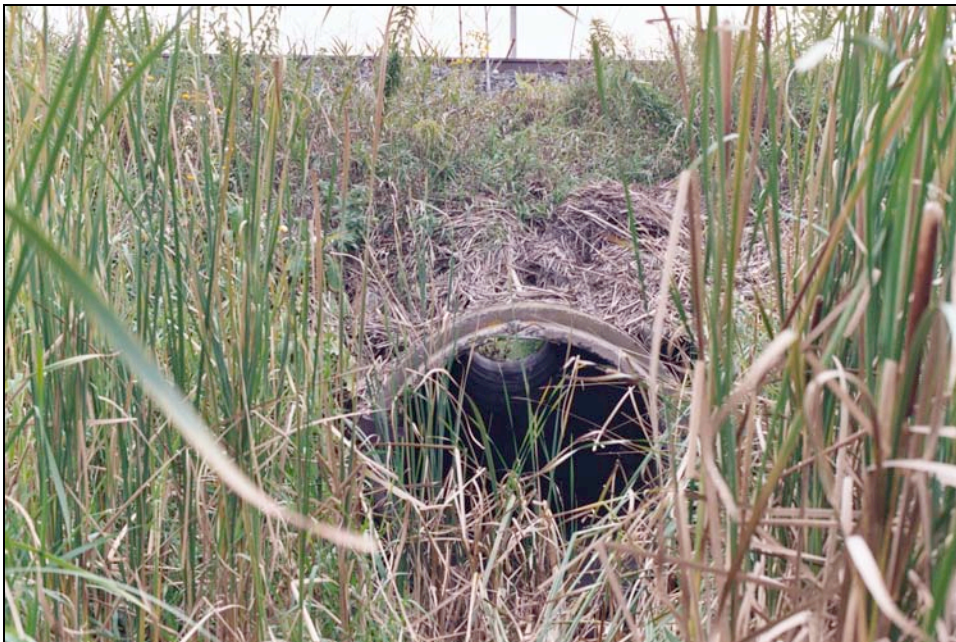
S36 Upstream side of one 48" concrete pipe, in good condition, no water (09-29-04), Section 31, T160N, R63W, N 599287.49, E 2401497.59, elevation 1572.7 @ invert of concrete pipe.

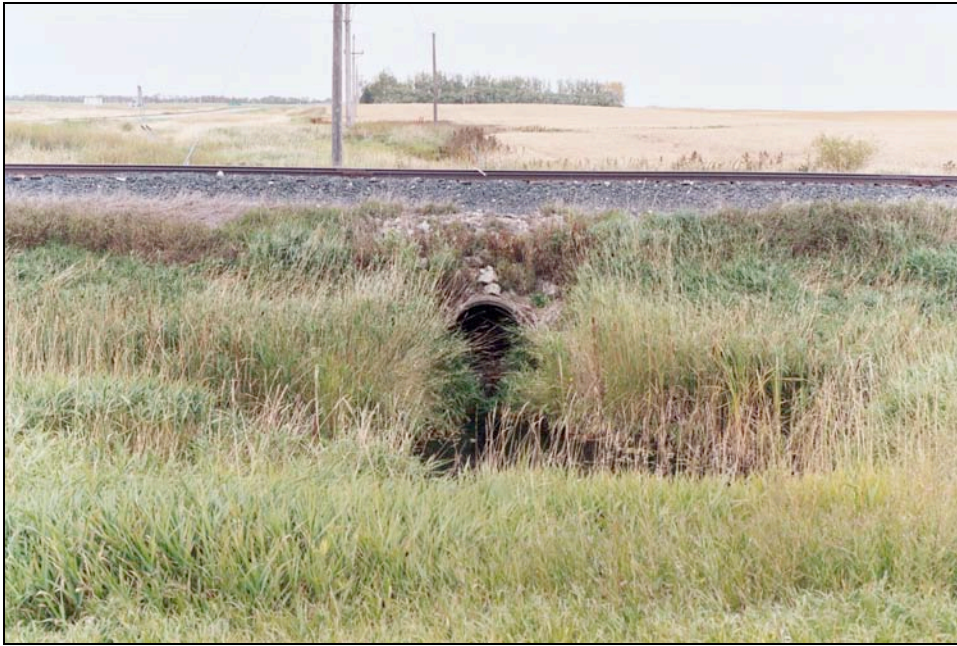
S36 Downstream side of one 48" concrete pipe, in good condition, no water (09-29-04), Section 31, T160N, R63W, N 599244.67, E 2401496.90, elevation 1572.4 @ invert of concrete pipe.

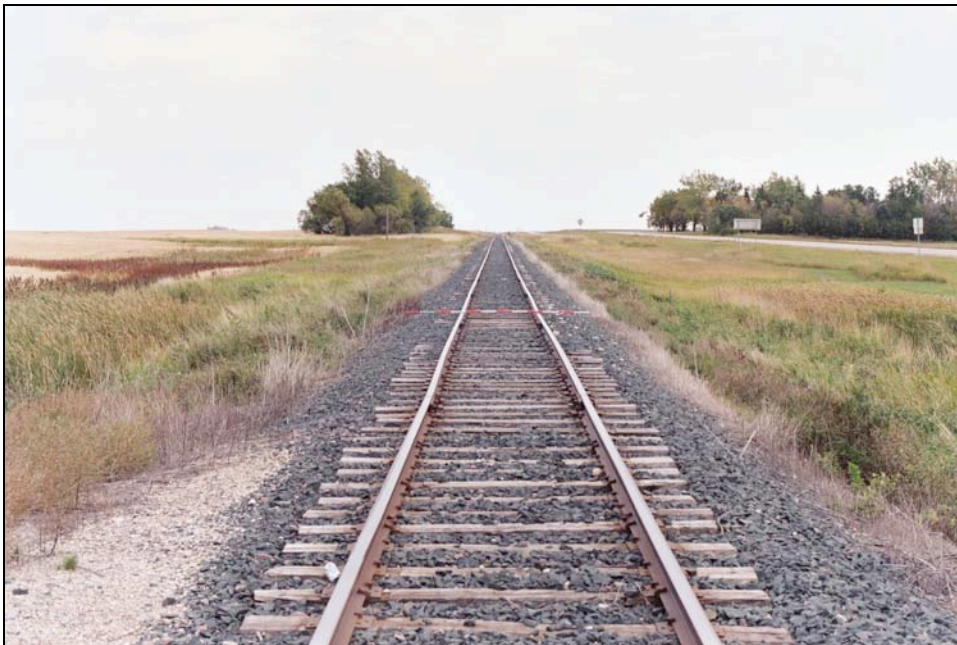
S36 Center of railroad crossing across one 48" CMP, looking east (09-29-04), Section 31, T160N, R63W, N 599265.99, E 2401496.83, elevation 1582.1 @ center of railroad crossing, top of gravel.

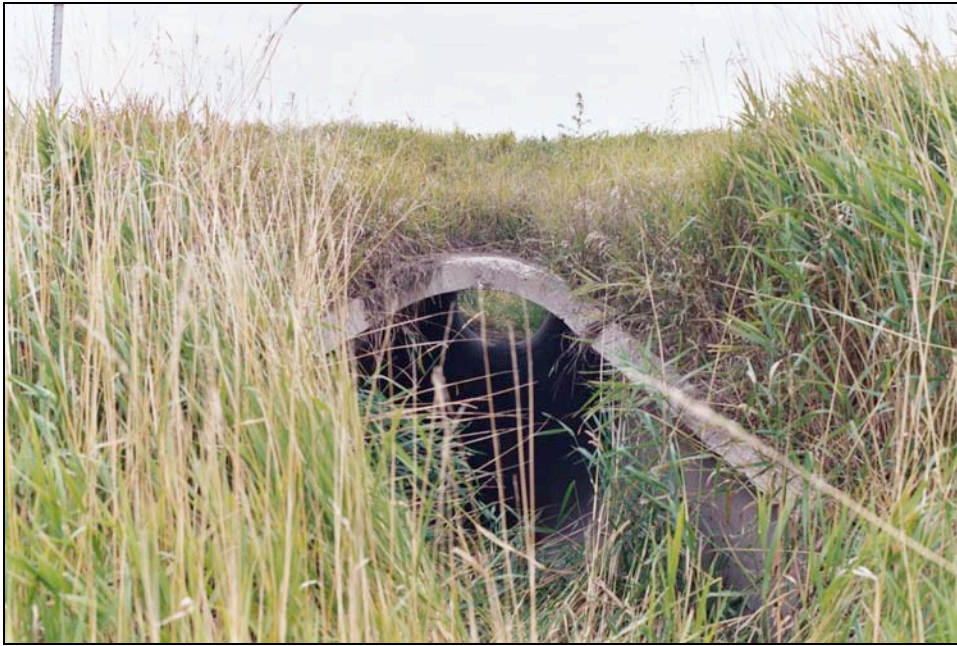
S37 Upstream side of one 48" concrete pipe & two 30" CMPs, in good condition no water (09-29-04), Section 36 & 31, T160N, R63 & 64W, N 599635.34, E 2401347.84, elevation 1572.2 @ invert of 48" concrete pipe, N 599638.39, E 2401347.72, elevation 1572.2 @ invert of 30" CMP, N 599650.40, E 2401356.96, elevation 1574.0 @ invert of 30" CMP.

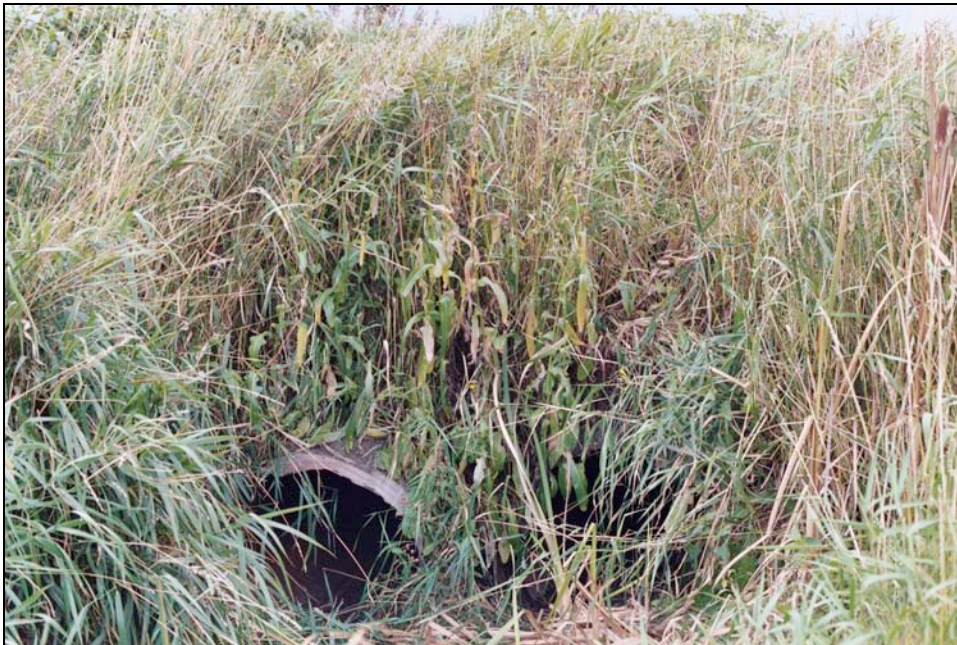
S37 Downstream side of one 48" concrete pipe & two 30" CMPs, in good condition, no water (09-29-04), Section 36 & 31, T160N, R63 & 64W, N 599604.53, E 2401409.10, elevation 1572.2 @ invert of 48" concrete pipe, N 599608.14, E 2401409.23, elevation 1572.4 @ invert of 30" CMP, N 599651.37, E 2401398.94, elevation 1573.8 @ invert of 30" CMP.

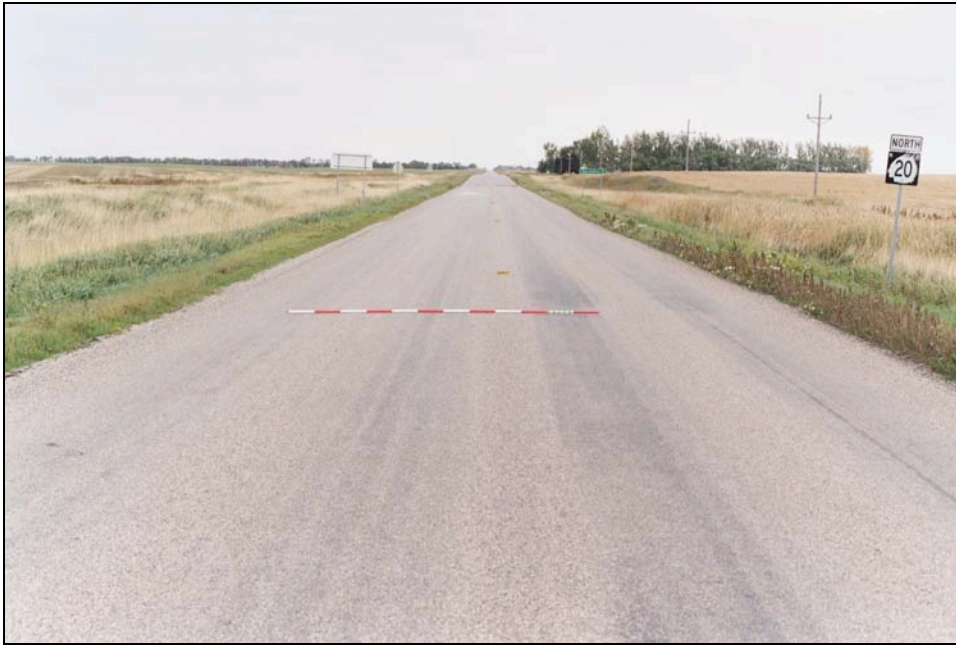
S37 Center of road crossing across one 48" concrete pipe & two 30" CMPs, looking north (09-29-04), Section 36 & 31, T160N, R63 & 64W, N 599637.21, E 2401379.11, elevation 1580.8 @ center of Hwy 20, top of asphalt.

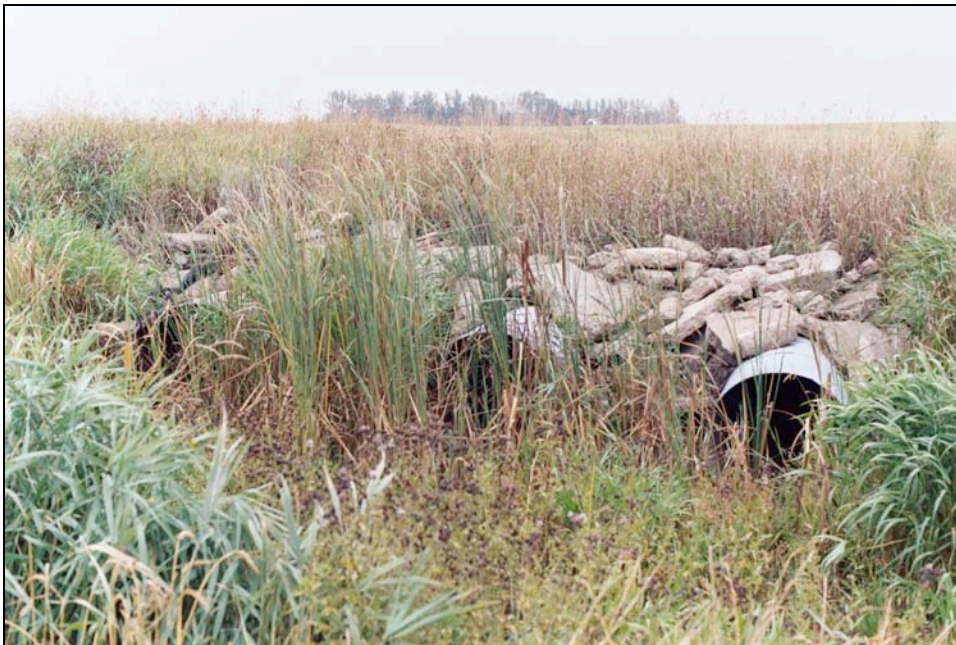
S38 Upstream side of three 36" CMPs, in good condition, no water, from east to west (09-30-04), Section 25 & 36, T160N, R64W, N 604459.39, E 2400338.39, elevation 1579.2 @ invert of 36" CMP, N 604459.92, E 2400329.35, elevation 1579.0 @ invert of 36" CMP, N 604460.00, E 2400322.68, elevation 1578.4 @ invert of 36" CMP.

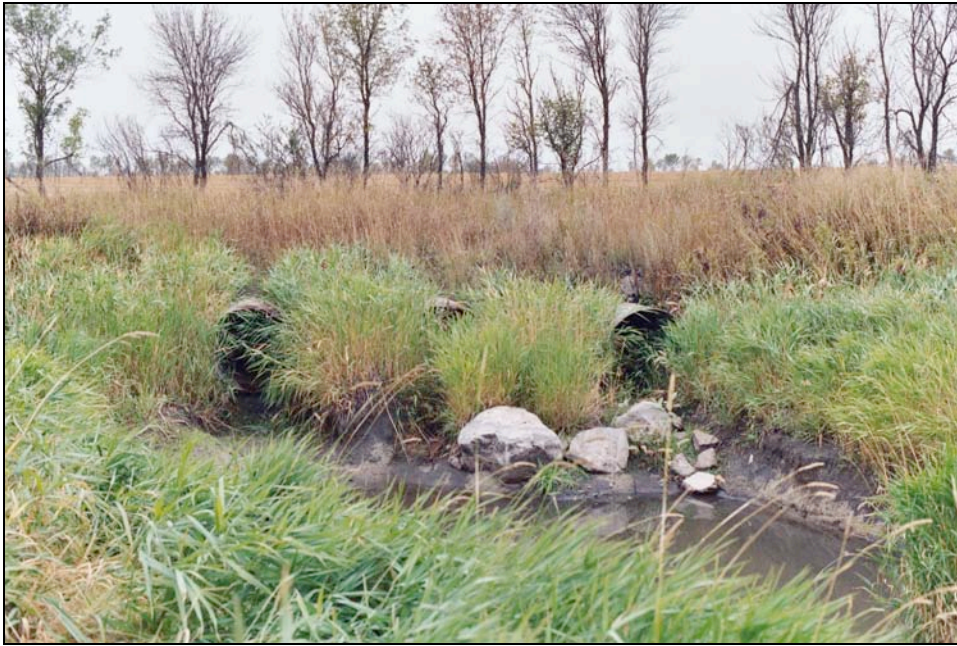
S38 Downstream side of three 36" CMPs, in good condition, no water, from east to west (09-30-04), Section 25 & 36, T160N, R64W, N 604412.85, E 2400348.27, elevation 1578.8 @ invert of 36" CMP, N 604413.85, E 2400341.13, elevation 1579.0 @ invert of 36" CMP, N 604413.60, E 2400334.26, elevation 1578.9 @ invert of 36" CMP.

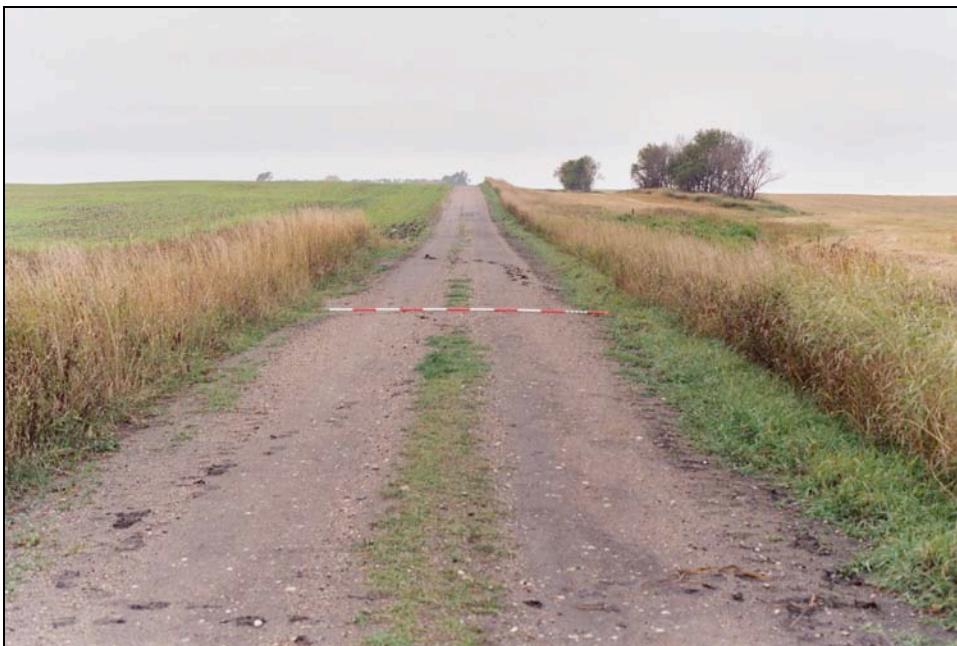
S38 Center of road crossing across three 36" CMPs, looking west (09-30-04), Section 25 & 36, T160N, R64W, N 604436.08, E 2400335.37, elevation 1584.1 @ center of road crossing, top of ground.

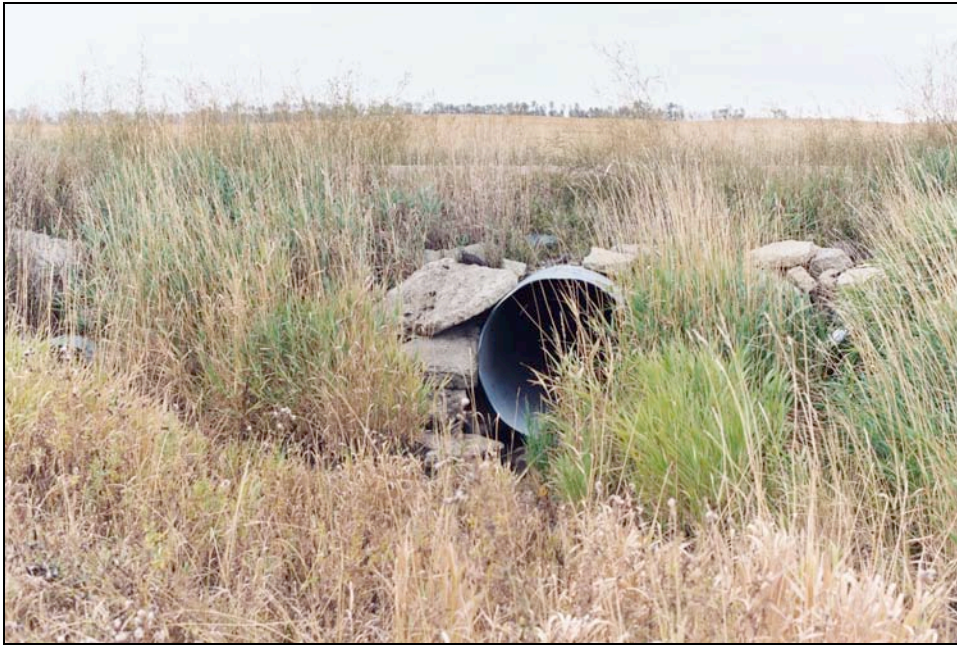
S39 Upstream side of one 36", one 48" & one 36" CMPs, in good condition, no water, from east to west (09-30-04), Section 24 & 25, T160N, R64W, N 609722.59, E 2399320.78, elevation 1584.0 @ invert of 36" CMP, N 609723.48, E 2399306.98, elevation 1585.2 @ invert of 48" CMP, N 609723.92, E 2399299.78, elevation 1585.0 @ invert of 36" CMP.

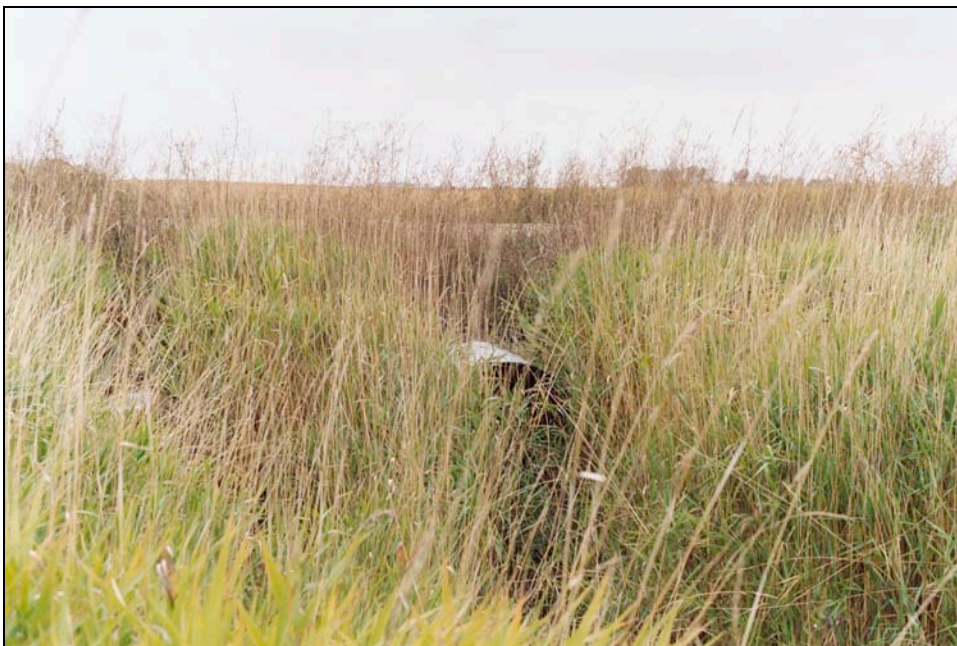
S39 Downstream side of one 36", one 48" & one 36" CMPs, in good condition, no water, from east to west (09-30-04), Section 24 & 25, T160N, R64W, N 609681.76, E 2399324.11, elevation 1585.4 @ invert of 36" CMP, N 609678.74, E 2399307.73, elevation 1584.8 @ invert of 48" CMP, N 609677.84, E 2399300.66, elevation 1584.9 @ invert of 36" CMP.

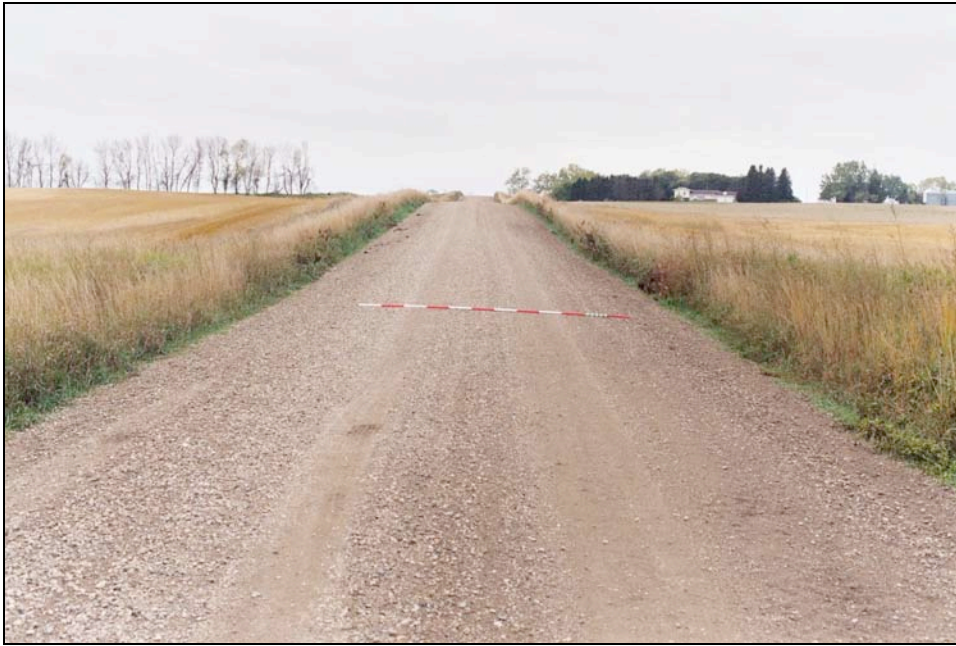
S39 Center of road crossing across on 36", one 48" & one 36" CMPs, looking west (09-30-04), Section 24 & 25, T160N, R64W, N 609699.90, E 2399306.79, elevation 1591.2 @ center of road crossing, top of gravel.

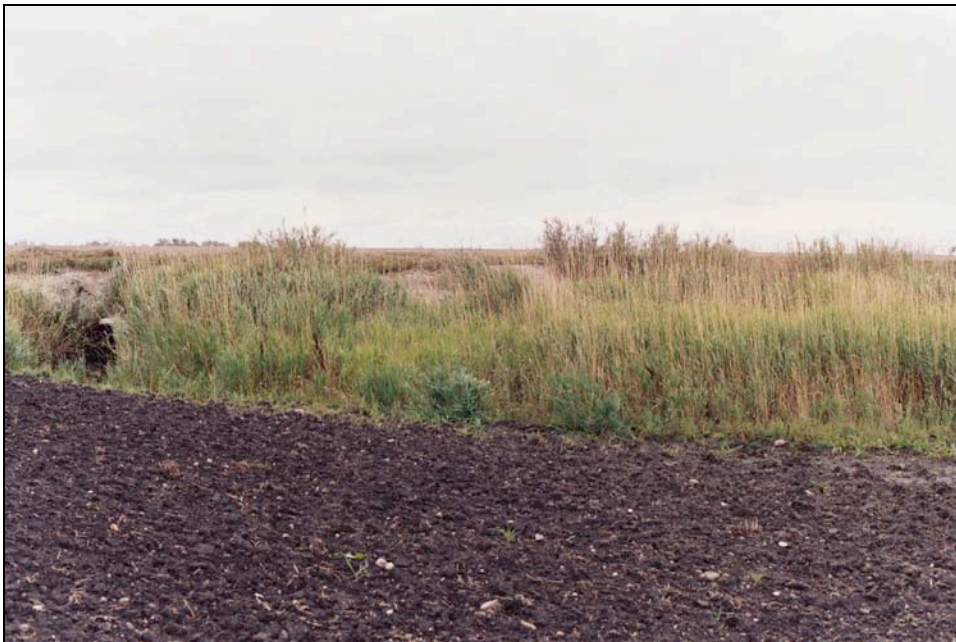
S40 Upstream side of three 36" CMPs, in good condition, no water, from east to west (09-30-04), Section 13 & 24, T160N, R64W, N 614996.76, E 2398864.53, elevation 1590.6 @ invert of 36" CMP, N 614998.40, E 2398844.88, elevation 1591.5 @ invert of 36" CMP, N 614994.88, E 2398827.78, elevation 1591.8 @ invert of 36" CMP.

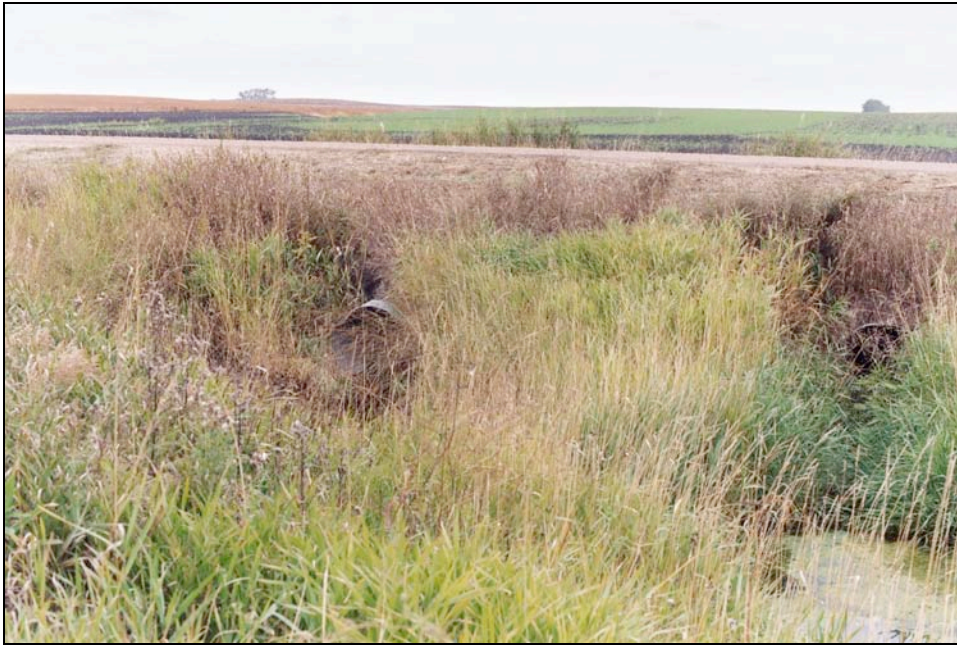
S40 Downstream side of three 36" CMPs, in good condition, no water, 0.4 feet & no water, from east to west (09-30-04), Section 13 & 14, T160N, R64W, N 614952.18, E 2398864.10, elevation 1590.3 @ invert of 36" CMP, N 614949.04, E 2398846.73, elevation 1589.9 @ invert of 36" CMP, N 614953.15, E 2398827.72, elevation 1591.5 @ invert of 36" CMP.

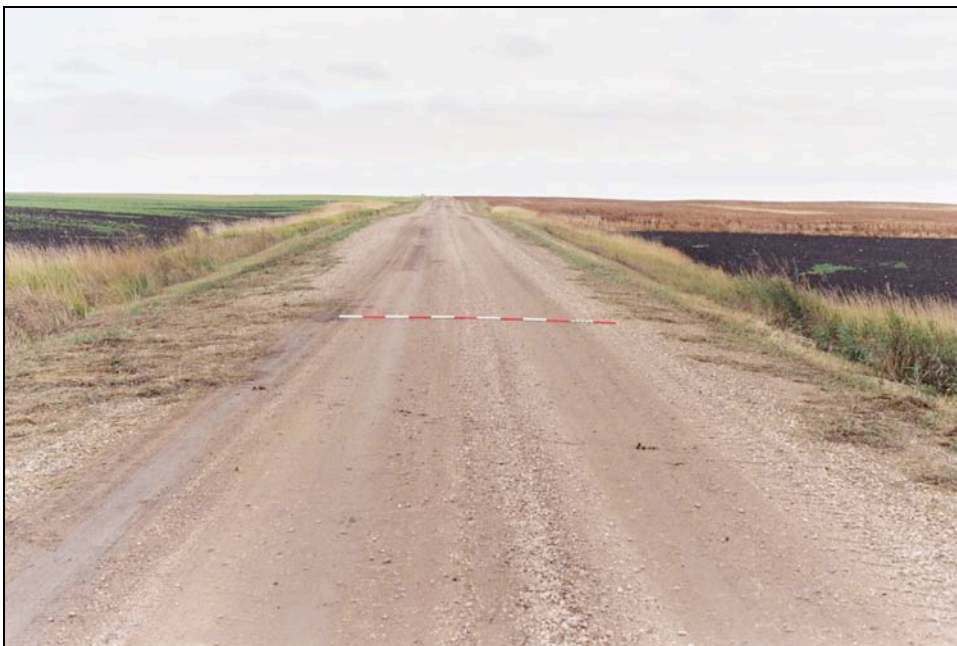
S40 Center of road crossing across three 36" CMPs, looking west (09-30-04), Section 13 & 24, T160N, R64W, N 614975.25, E 2398846.68, elevation 1597.9 @ center of road crossing, top of gravel.

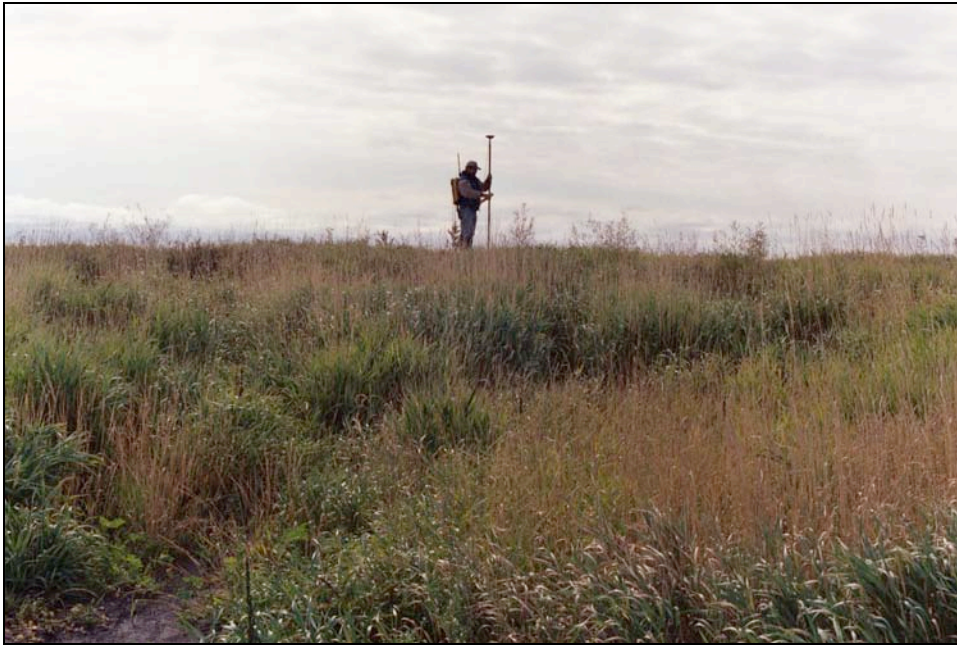
S41 Upstream side of three 36" CMPs, in good condition, no water, from east to west (09-30-04), Section 12 & 13, T160N, R64W,
 N 620268.98, E 2397879.55, elevation 1595.6 @ invert of 36" CMP,
 N 620268.85, E 2397865.19, elevation 1595.3 @ invert of 36" CMP,
 N 620267.69, E 2397850.69, elevation 1594.4 @ invert of 36" CMP.

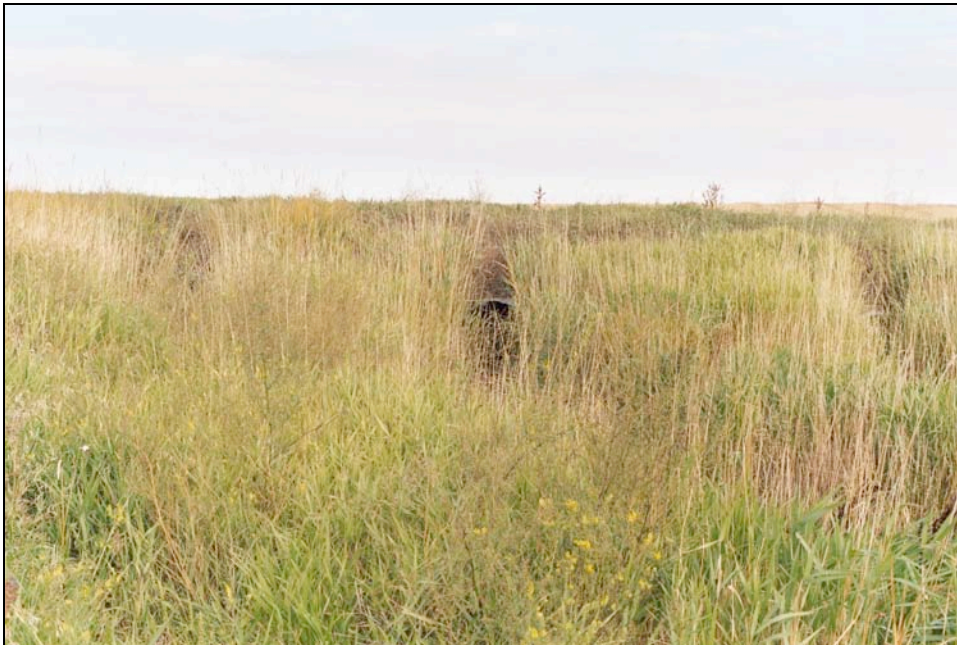
S41 Downstream side of three 36" CMPs, in good condition, no water, from east to west (09-30-04), Section 12 & 13, T160N, R64W,
 N 620227.63, E 2397881.66, elevation 1594.9 @ invert of 36" CMP,
 N 620227.22, E 2397865.25, elevation 1594.9 @ invert of 36" CMP,
 N 620229.48, E 2397850.76, elevation 1595.6 @ invert of 36" CMP.

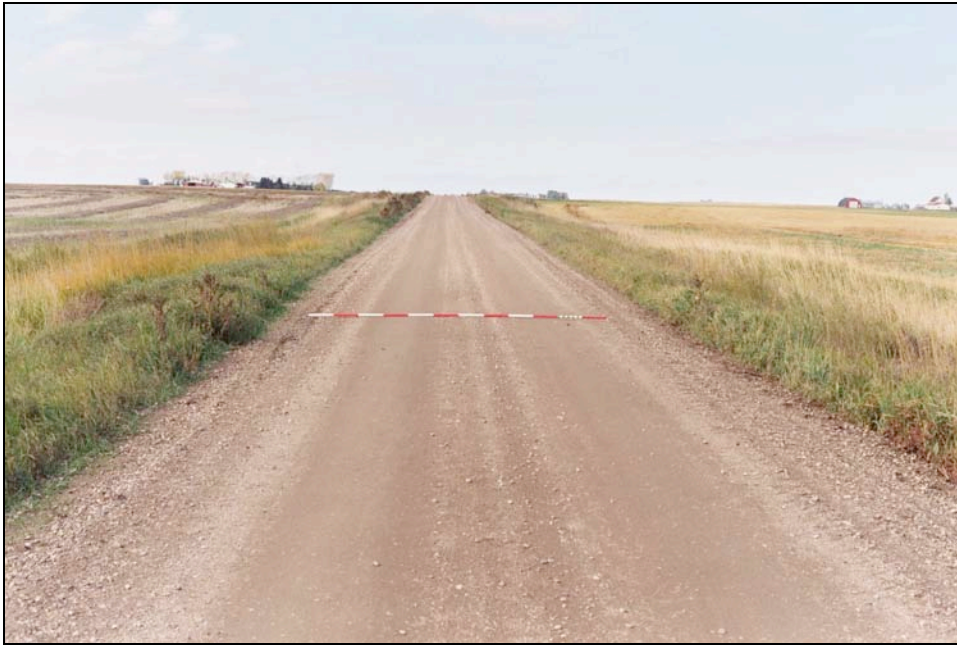
S41 Center of road crossing across three 36" CMPs, looking west (09-30-04), Section 12 & 13, T160N, R64W, N 620248.26, E 2397865.62, elevation 1601.5 @ center of road crossing, top of gravel.

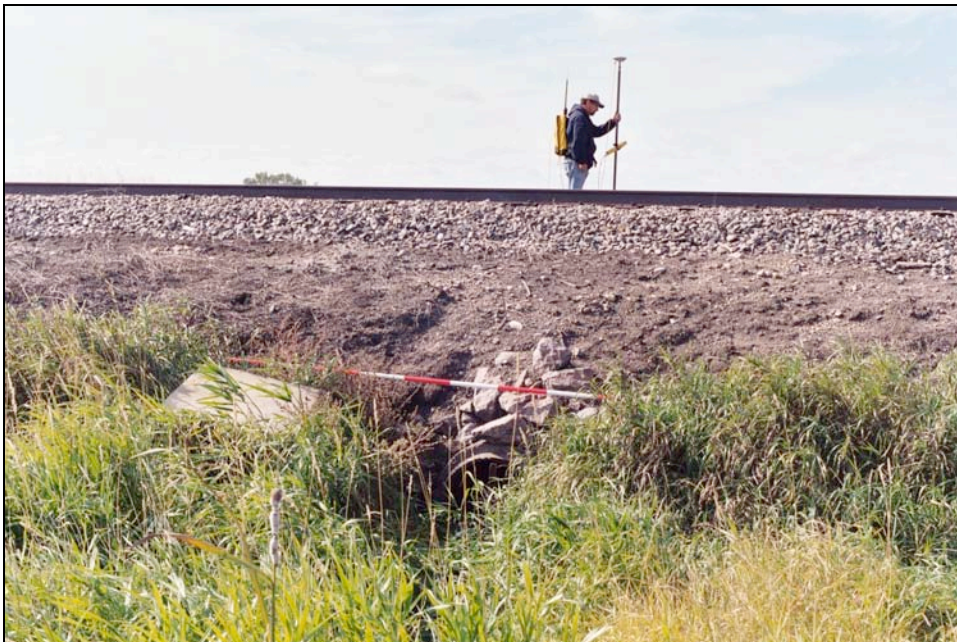
S42 Upstream side of one 24" concrete pipe, in good condition, no water (09-30-04), Section 12, T160N, R64W, N 623713.79, E 2397593.78, elevation 1598.2 @ invert of concrete pipe.

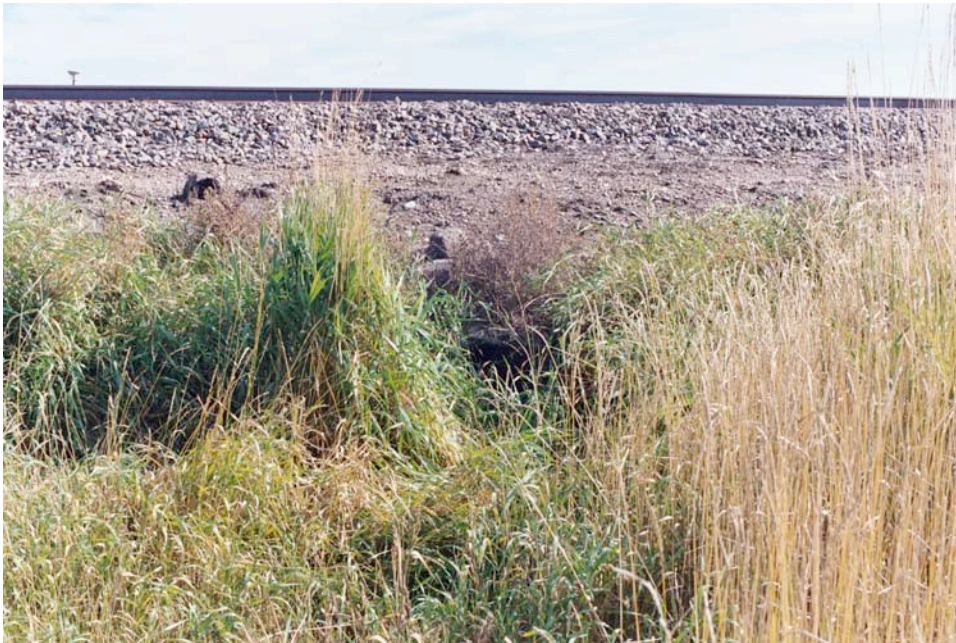
S42 Downstream side of one 24" concrete pipe, in good condition, no water (09-30-04), Section 12, T160N, R64W, N 623699.61, E 2397558.69, elevation 1598.8, @ invert of concrete pipe.

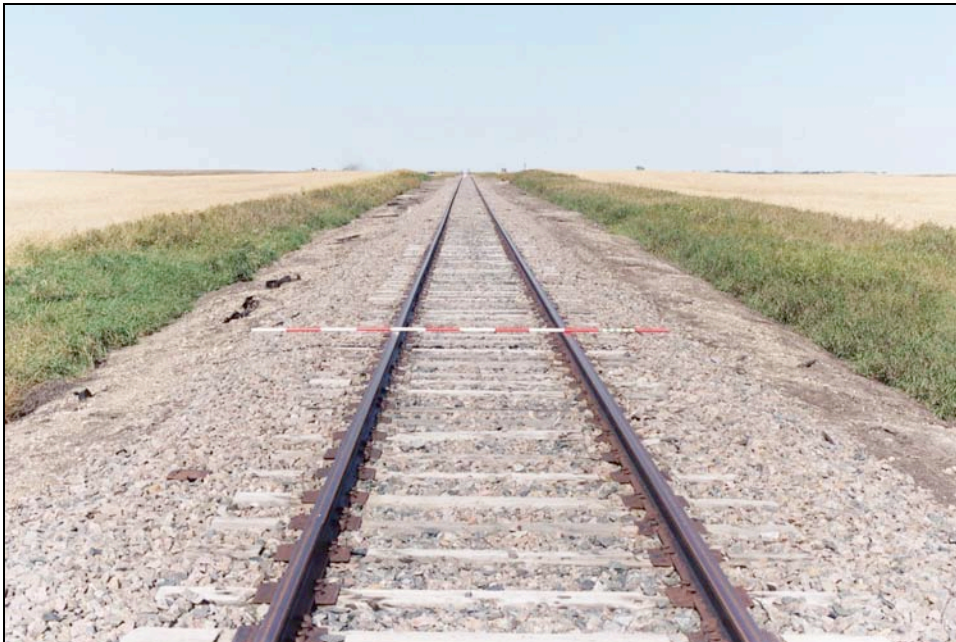
S42 Center of railroad crossing across one 24" CMP, looking north-west (09-30-04), Section 12, T160N, R64W, N 623707.28, E 2397576.54, elevation 1605.2 @ center of railroad crossing, top of gravel.

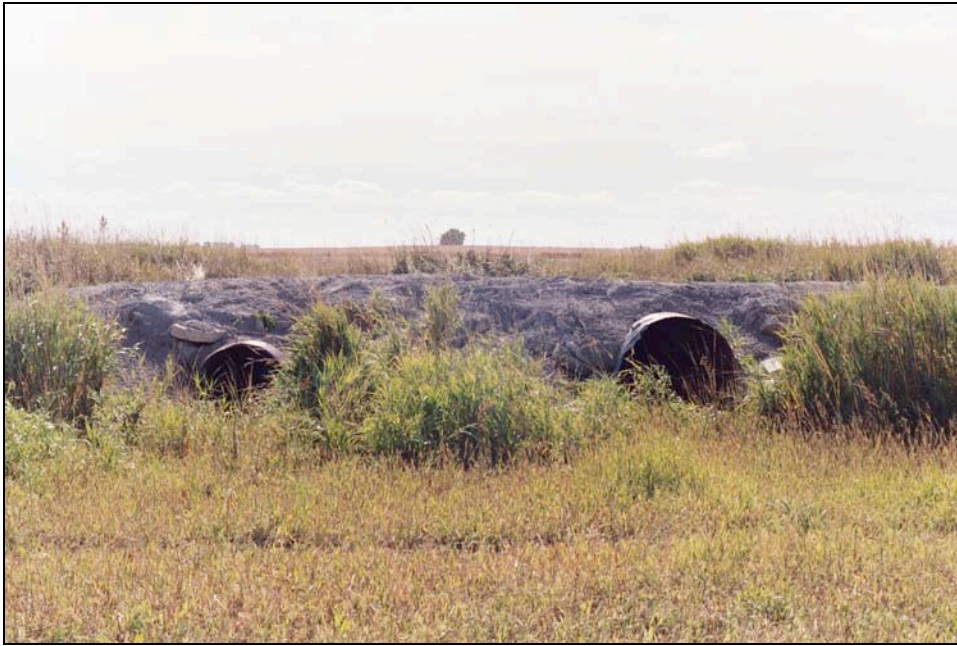
S43 Upstream side of one 36" & one 48" CMPs, in good condition, no water, east to west (09-30-04), Section 1 & 12, T160N, R64W, N 625560.78, E 2398105.55, elevation 1599.3 @ invert of 36" CMP, N 625559.98, E 2398091.36, elevation 1599.0 @ invert of 48" CMP.

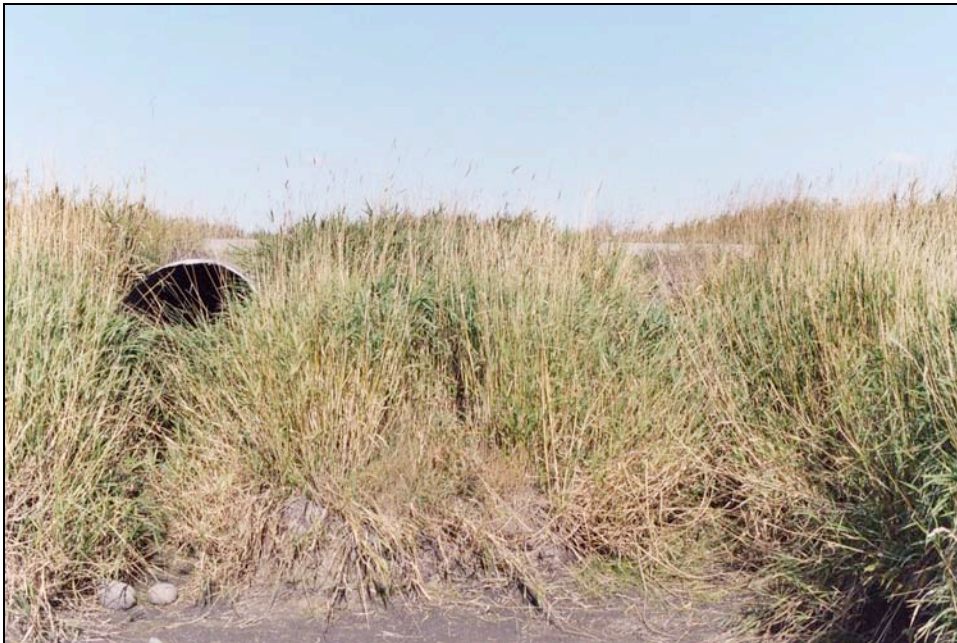
S43 Downstream side of one 36" & one 48" CMPs, in good condition, no water, east to west (09-30-04), Section 1 & 12, T160N, R64W, N 625514.37, E 2398105.39, elevation 1598.7 @ invert of 36" CMP, N 625512.53, E 2398093.17, elevation 1598.9 @ invert of 48" CMP.

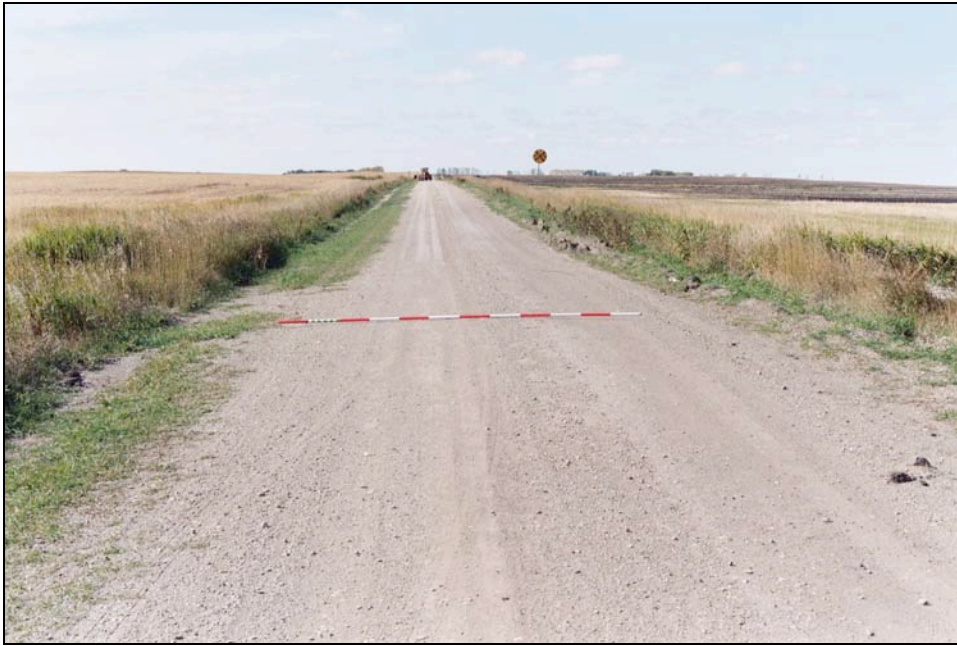
S43 Center of road crossing across one 36" & one 48" CMPs, looking west (09-30-04), Section 1 & 12, T160N, R64W, N 625532.99, E 2398097.24, elevation 1603.8 @ center of road crossing, top of gravel.

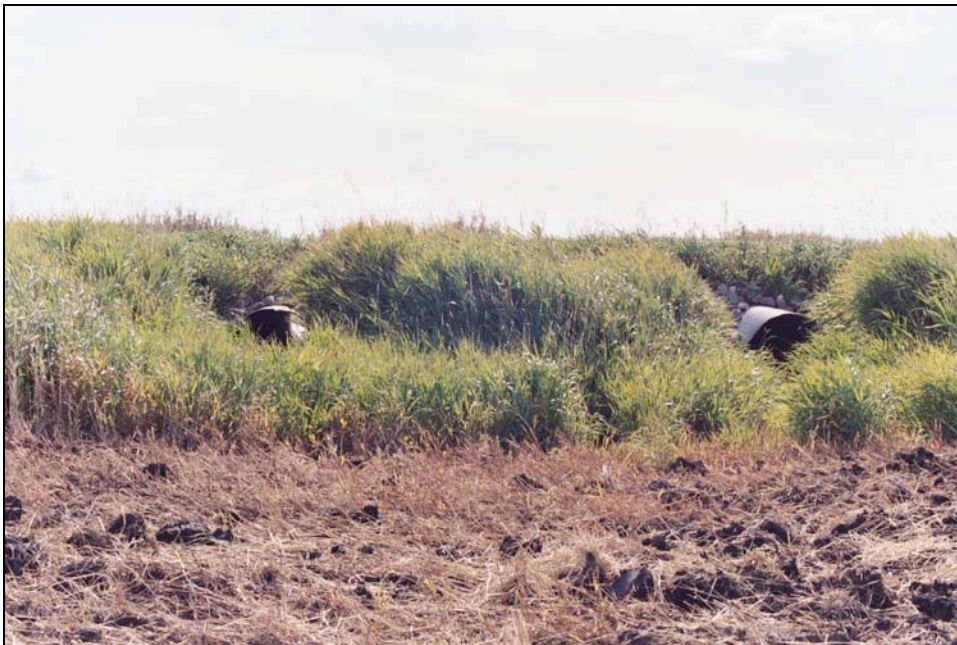
S44 Upstream side of two 48" CMPs, in good condition, no water, west to east (09-30-04), Section, 31 & 1, T160 & 161N, R64W, N 630938.89, E 2395597.95, elevation 1602.6 @ invert of 48" CMP, N 630940.99, E 2395616.37, elevation 1604.1 @ invert of 48" CMP.

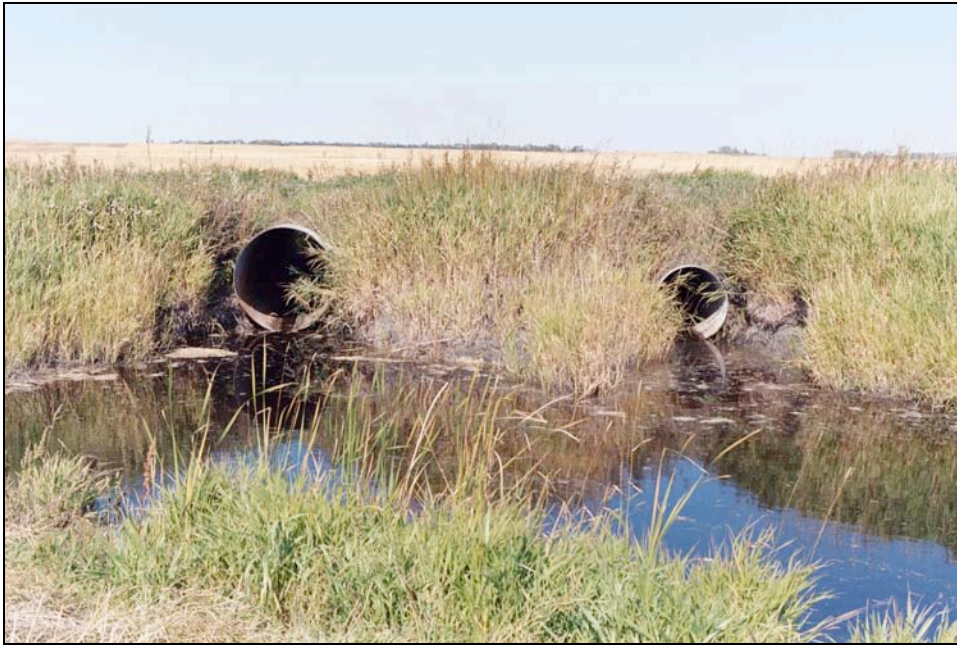
S44 Downstream side of two 48" CMPs, in good condition, no water, west to east (09-30-04), Section 31 & 1, T160 & 161N, R64W, N 630903.87, E 2395600.26, elevation 1603.6 @ invert of 48" CMP, N 630903.24, E 2395616.79, elevation 1603.5 @ invert of 48" CMP.

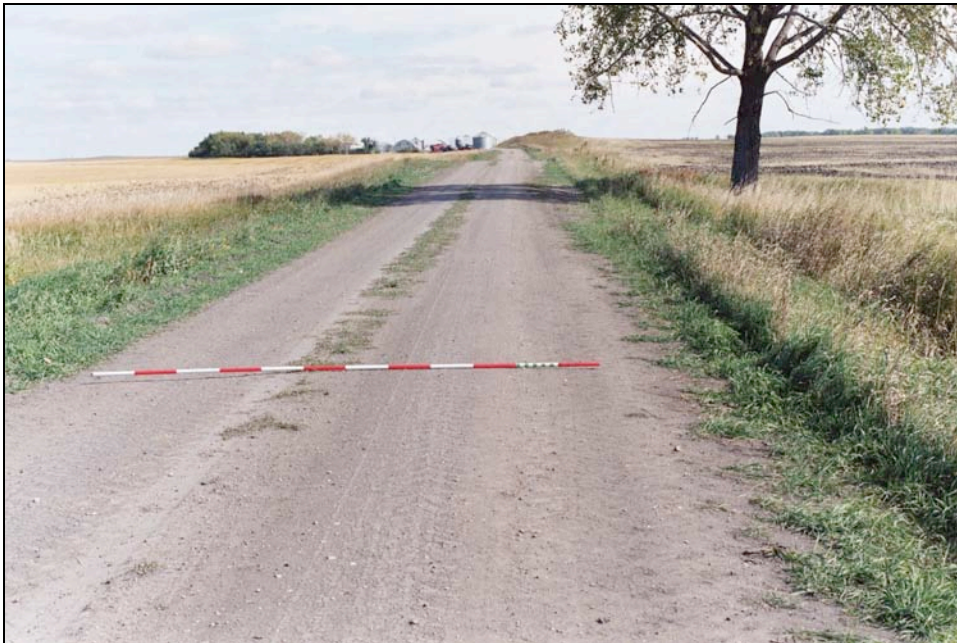
S44 Center of road crossing across two 48" CMPs, looking east (09-30-04), Section 31 & 1, T160 & 161N, R64W, N 630921.08, E 2395608.14, elevation 1608.9 @ center of road crossing, top of gravel.

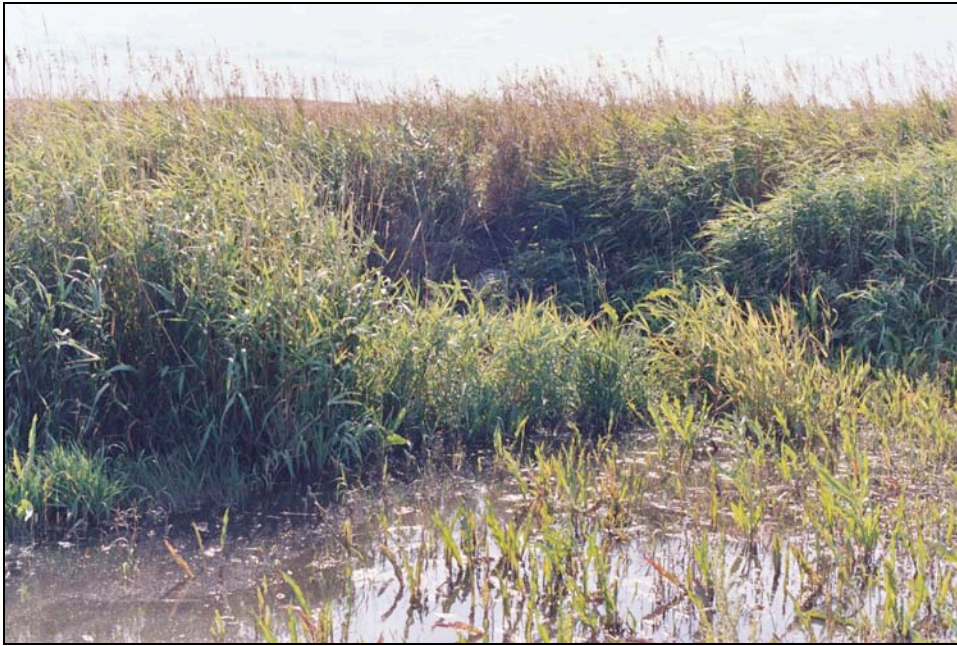
S45 Upstream side of one 24" CMP, in poor condition, no water (09-30-04), Section 30 & 31, T161N, R64W, N 636231.92, E 2396328.16, elevation 1606.6 @ invert of CMP.

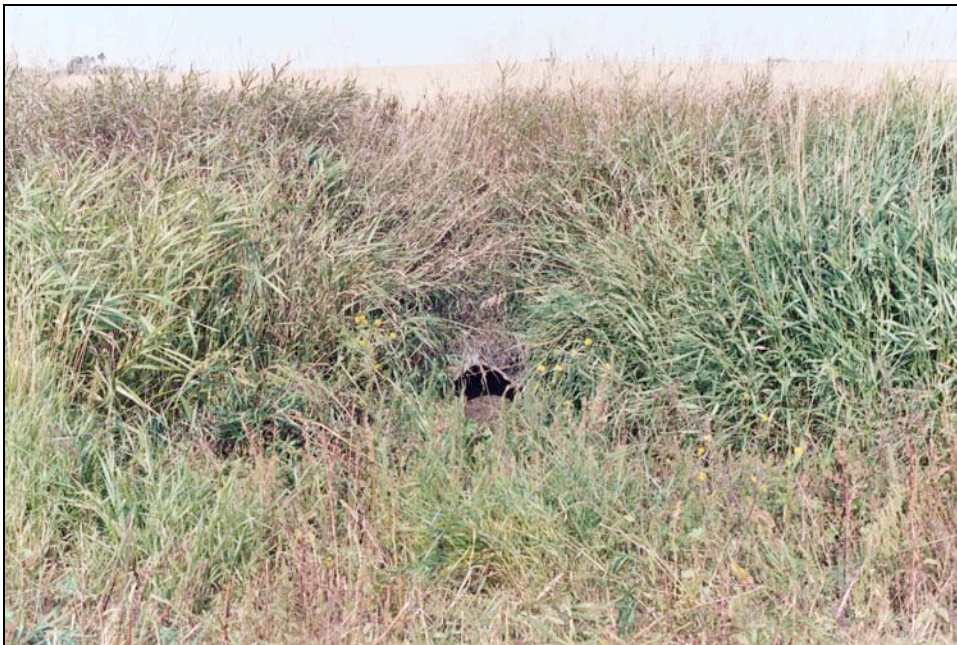
S45 Downstream side of one 24" CMP, in poor condition, 0.7 feet of water (09-30-04), Section 30 & 31, T161N, R64W, N 636210.78, E 2396327.23, elevation 1605.2 @ invert of CMP.

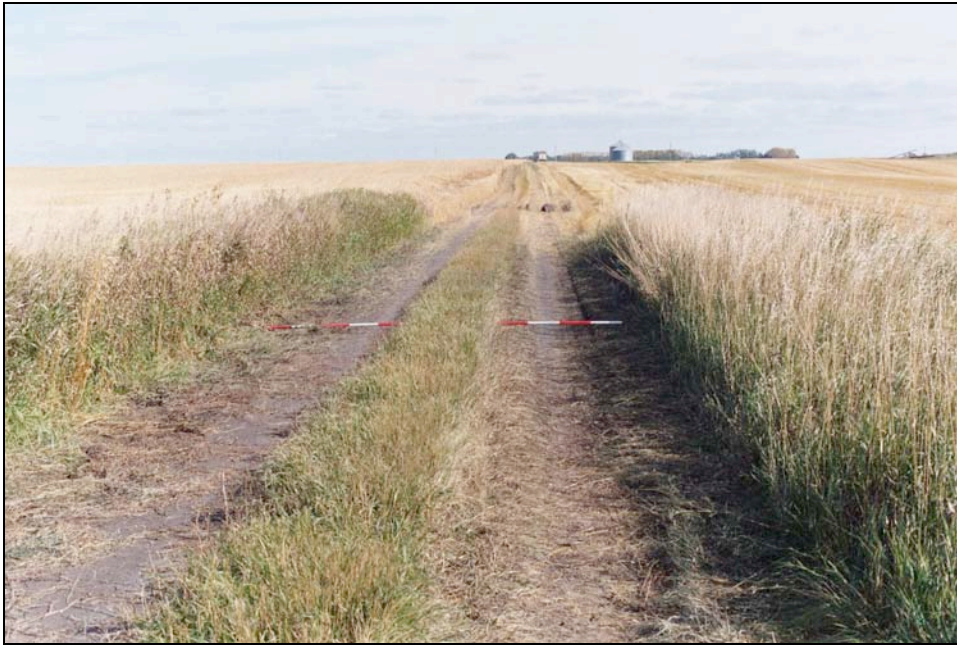
S45 Center of road crossing across one 24" CMP, looking east (09-30-04), Section 30 & 1, T161N, R64W, N636221.77, E 2396327.16, elevation 1609.0 @ center of trail crossing, top of ground.

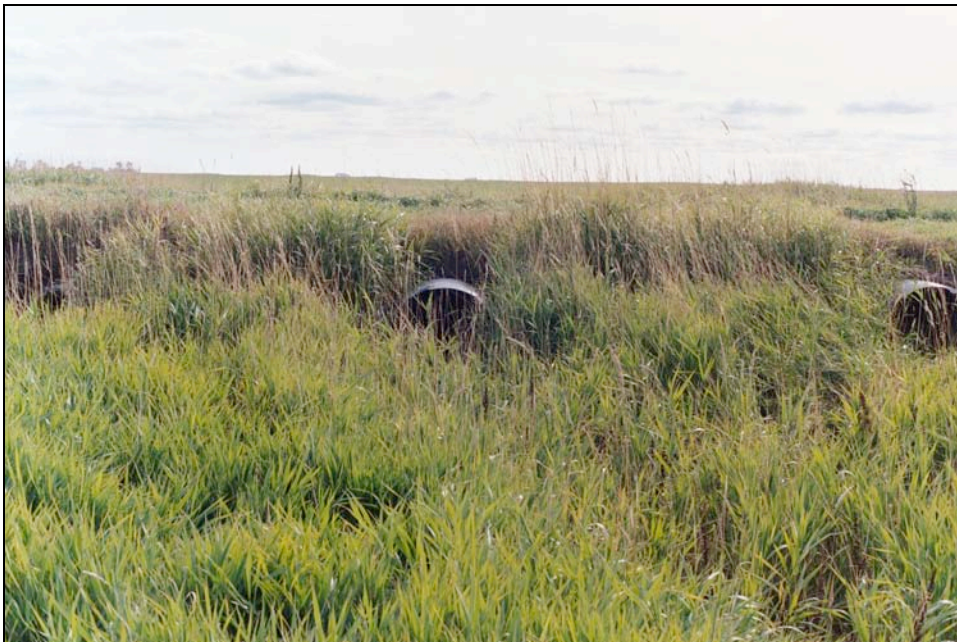
S46 Upstream side of two 48" CMP & one 30" concrete pipe, in good condition, no water, from west to east (09-30-04), Section 24 & 25, T161N, R64W, N 641454.77, E 2393066.34, elevation 1607.6 @ invert of 48" CMP, N 641457.12, E 2393080.29, elevation 1607.3 @ invert of 48" CMP, N 641452.16, E 2393091.80, elevation 1607.4 @ invert of 30" CMP.

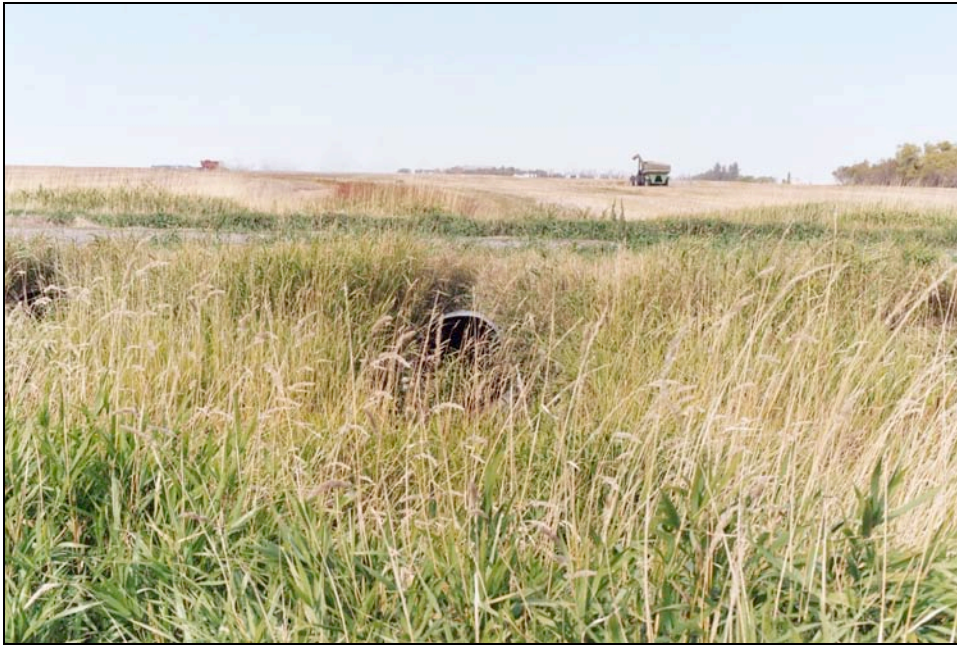
S46 Downstream side of two 48" CMP & one 30" concrete pipe, in good condition, no water, from west to east (09-30-04), Section 24 & 25, T161N, R64W,
 N 641417.48, E 2393067.52, elevation 1607.7 @ invert of 48" CMP,
 N 641414.85, E 2393079.59, elevation 1607.5 @ invert of 48" CMP,
 N 641414.54, E 2393092.68, elevation 1607.7 @ invert of 30" CMP.
